SUMMARY REPORT

FIRE SPRINKLER SYSTEM PERFORMANCE BUILDING FIRE

GWINNETT CLEAN & BEAUTIFUL
4300 SATELLITE BOULEVARD
DULUTH, GEORGIA

February 28, 2013

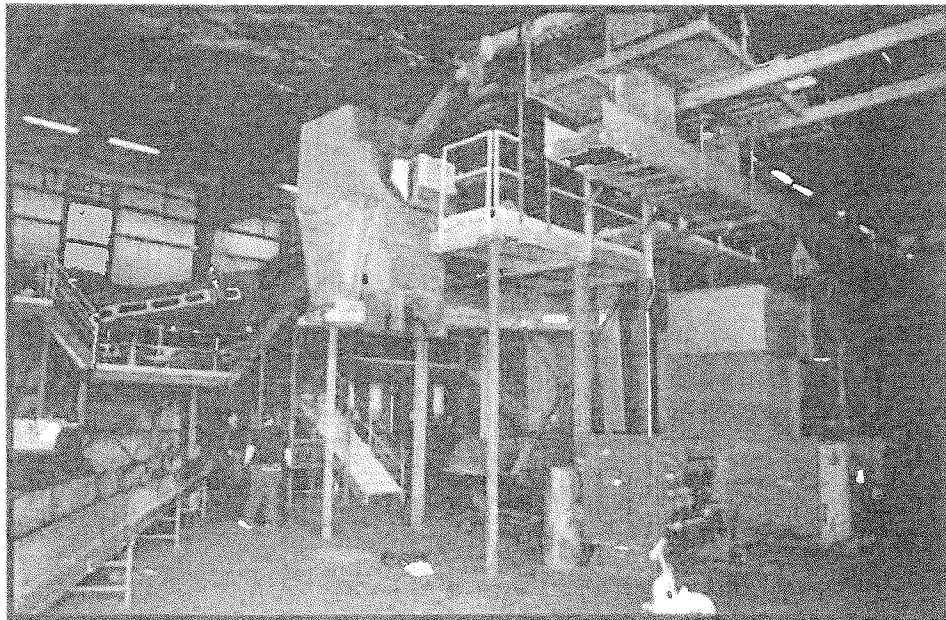
A nominally 5-foot wide transfer conveyor located, in part, on a mezzanine structure traverses over the feed conveyor to the Eddycurrent. The fire originated at the Eddycurrent itself and spread to the obstructed area created by the overhead transfer conveyor. This obstructed area created by the transfer conveyor blocked the intended application of water from sprinklers at the ceiling level above which allowed the fire to spread unchecked to involve and heavily damage the conveyor belts and equipment in the obstructed area.

General Area Showing Eddycurrent and Transfer Conveyor

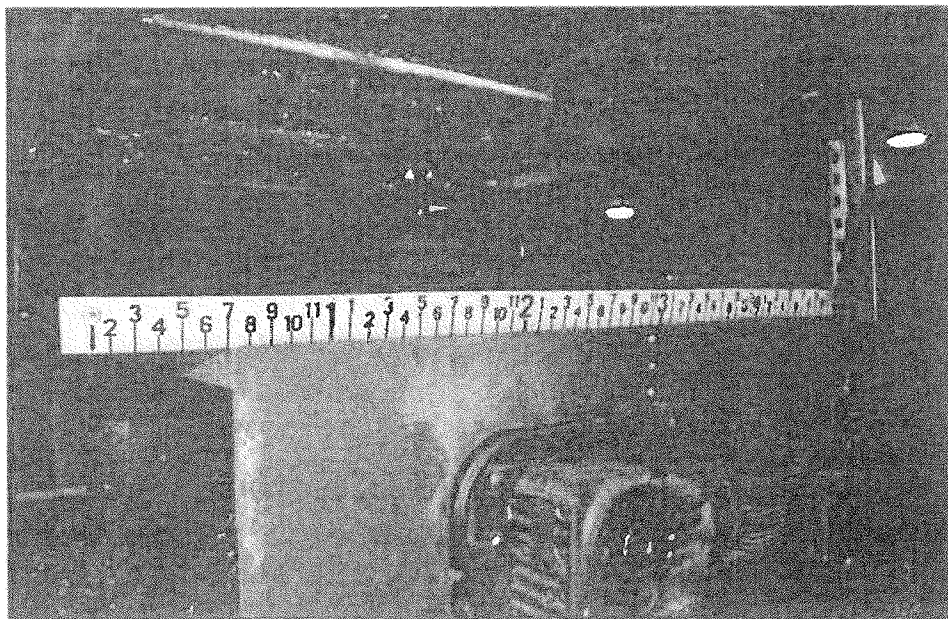
As noted above, the subject fire which initially started in the Eddycurrent spread to an area beneath a nominally 5-foot wide transfer conveyor that traversed the Eddy current feed conveyor. This created an obstructed area that prevented ceiling sprinkler discharge from reaching the hazard area below the transfer conveyor. Since the transfer conveyor was greater than 4-feet wide, sprinklers were required in this area per NFPA 13. However, there were no such sprinklers were installed in this area at the time of fire. Due to these missing sprinklers, the fire was allowed to continue to burn/spread within the concealed areas causing severe damage to the transfer belt and related equipment.

Based on information currently available and my analysis to date, the lack of fire sprinklers under the nominal 5-foot wide transfer conveyor near the Eddycurrent as required by NFPA 13, the scope of work narrative and D&C's proposal was the principal cause which allowed the fire to spread from the Eddycurrent into the concealed area created by the transfer belt allowing extensive damage to the transfer belt and surrounding equipment. If fire sprinklers had been installed to protect the obstructed areas as required by applicable codes and the scope of work, it is likely that the damage resulting from this fire would have been limited to the Eddycurrent and its associated feed belt.

Obstructed Area under Transfer Conveyor at Eddycurrent Feed

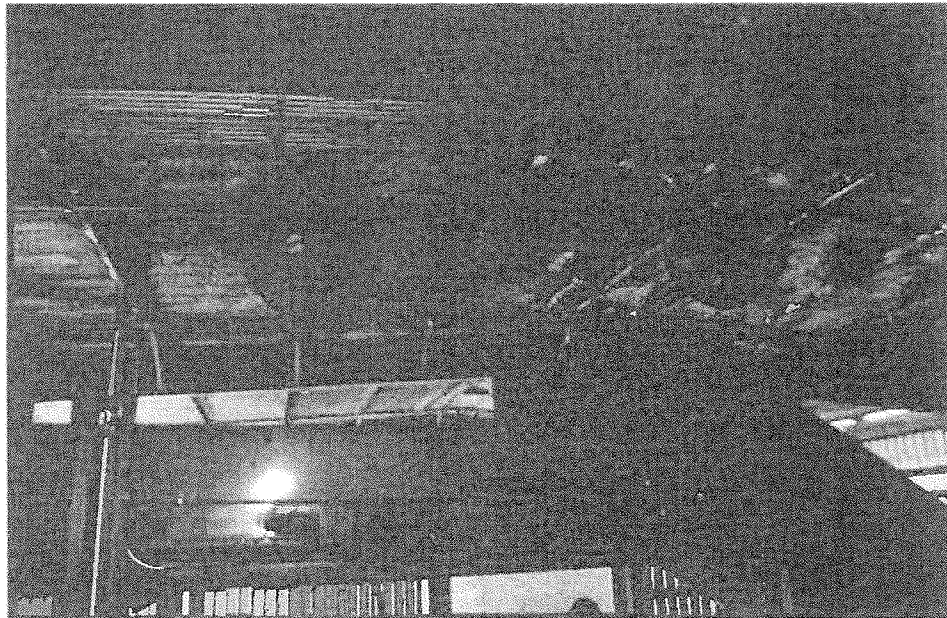
Example Area under Transfer Conveyor
(Note: Sprinklers added after fire)

Subsequent to the fire, the Office of the Fire Marshal of Gwinnett County issued a Notice of Non-Compliance identifying this obstructed area (among others) as having inadequate sprinkler coverage per the requirements of NFPA 13 and required that additional sprinklers were installed.

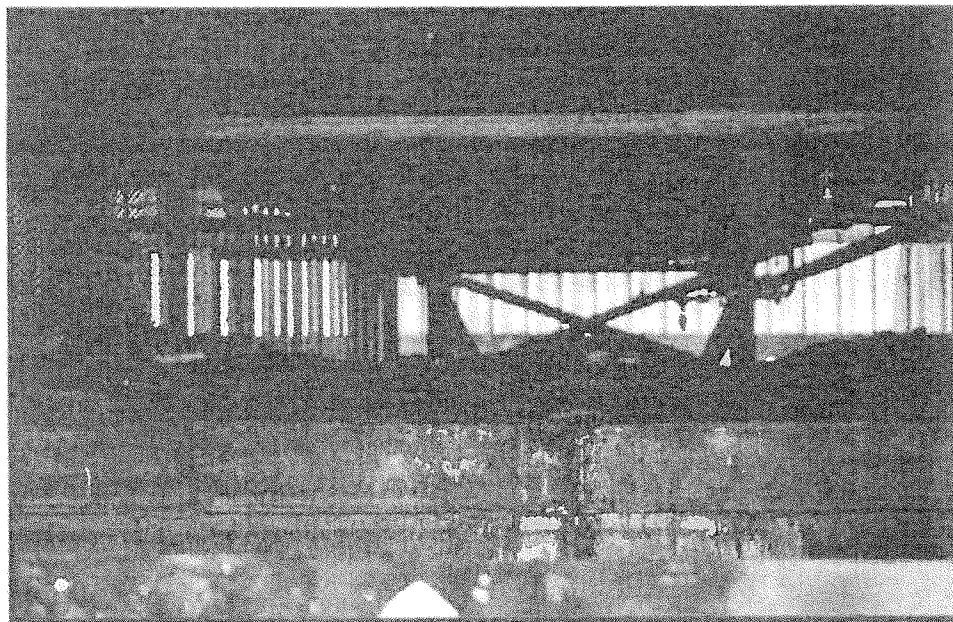
Example Area under Transfer Conveyor
(Note: Sprinklers added after fire)
